# RH2 TECHNICAL MEMORANDUM

Client: City of Cashmere  
Project: Sherman Reservoir Assessment  
Project File: CA 211.038.22 Project Manager: Ryan Peterson, PE  
Composed by: Shannon Emerick, PE and Ryan Peterson, PE  
Reviewed by: Jon Conner, PE, SE, and Randy Asplund, PE  
Subject: Sherman Reservoir Assessment  
Date: November 21, 2019

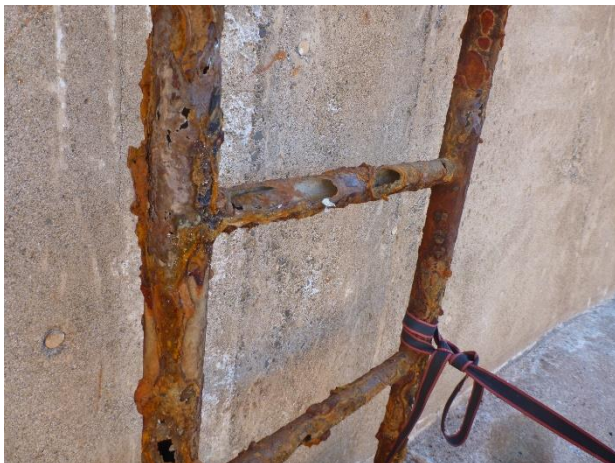
Severe corrosion of the interior fixed ladder (**Photo 1**) and the bottom fitting of the overflow piping (**Photo 2**) was observed. The upper portion of the ladder may be retained as a handhold and the more corroded bottom section may be removed. A new full height ladder will be installed in a different location. During the site visit, City employees expressed the desire to avoid replacing the overflow piping, if possible. The eye bolts that suspend the pumps are above the normal water line and appeared to be free of significant corrosion, although limited access did not allow their close inspection.

Photo 1: Existing Ladder

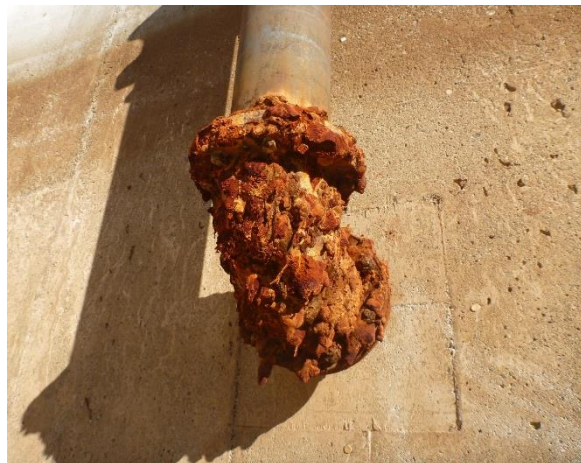
Photo 2: Existing Overflow Piping

RH2 recommends that, in addition to the ladder already slated for replacement, the overflow piping be replaced or cleaned and painted to reduce rust sediment in the water, thereby improving the ability to inspect for rebar corrosion.

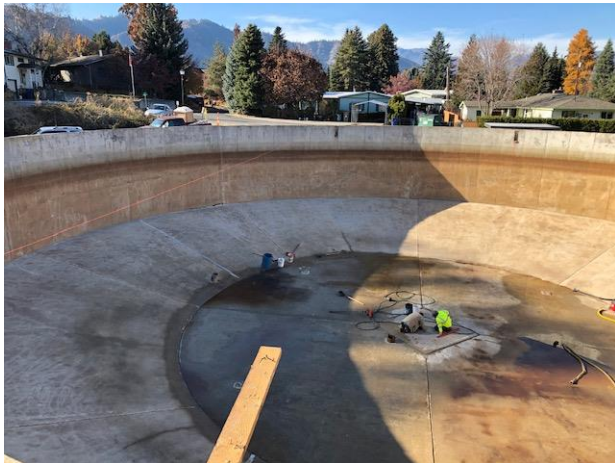
Rust-colored sediment, likely from the corroding steel distribution mains, covered much of the interior face of the floor (**Photo 3**) and walls, particularly in the range of the normal operating level of the tank (**Photo 4**) and at surface irregularities in the wall and floor. This made it difficult to identify areas of possible concrete spalling and rebar corrosion. High on the northeast interior face of the wall (also **Photo 4**), near the overflow pipe, a roughly 2-foot-long area has the characteristic appearance of concrete spalling and rebar corrosion, although this is well above the water level.

Photo 3: Rust Sediment at Tank Floor

At all spots of rust-colored debris, which could indicate rebar corrosion, RH2 recommends that the area be ground back to clean concrete and/or steel to confirm whether the rust-colored debris is the result of rebar corrosion. If it is discovered that rebar corrosion is the source of the debris, it is recommended that the bars be ground clean to a distance of 6 inches minimum beyond any sign of corrosion and then patched/sealed to discontinue the corrosion that, left unchecked, will continue along affected bars and potentially affect other bars that come in contact with the affected bars. If rebar corrosion is not discovered to be the source of the sediment, the area may be patched or sealed without further exploration.

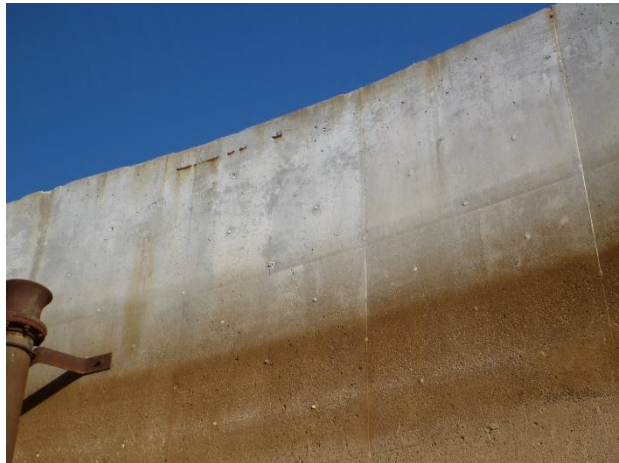
Photo 4: Rebar Corrosion at Top of Wall

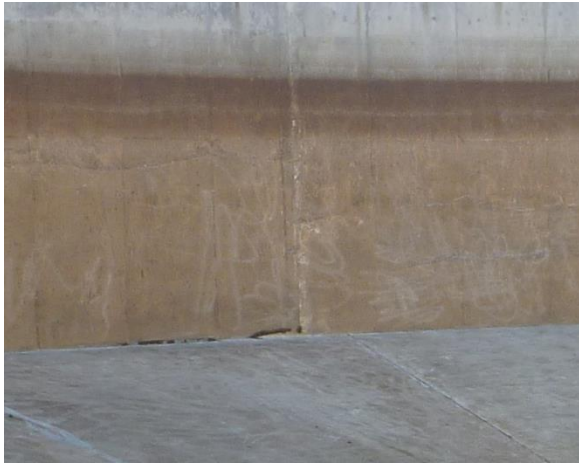
At the southwest portion of the wall and floor intersection there is a roughly 12-foot-long region of potential rebar corrosion (**Photo 5**). At that location, it was not possible to discern whether the rust sediment was a result of rust sediment being drawn through the concrete from interior to exterior (due to hydrostatic loads and concrete porosity), or the result of rebar corrosion and associated concrete spalling inside the wall. Using the tip of a screwdriver, one spot in this region (**Photo 6**) was abraded, and despite abrading off approximately ½-inch of rusty concrete, no clean concrete or clean bar was reached. Numerous discolored points on the floor and several other points on the wall could also be signs of rebar corrosion, although none appeared significant.

Photo 5: Area of Potential Rebar Corrosion

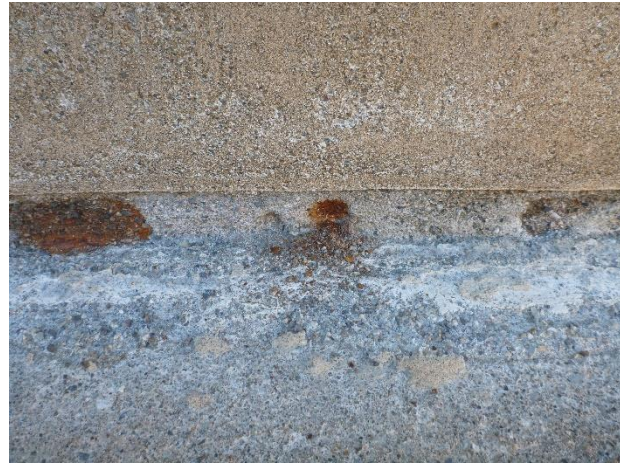
Photo 6: Potential Rebar Corrosion

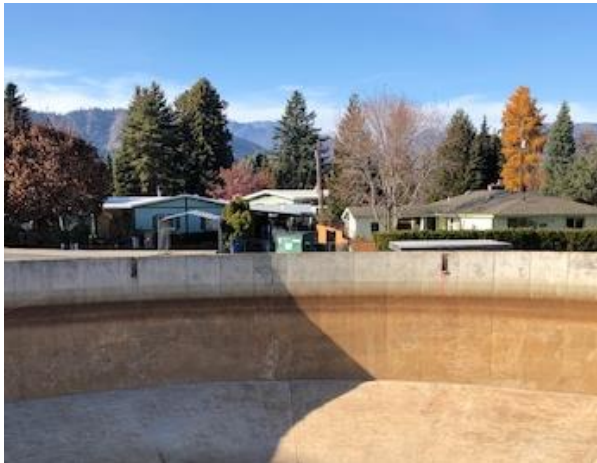
At the top surface of the walls, the existing anchor bolts have been removed to within a fraction of an inch above the concrete surface. All other roof elements have been removed as well. At four locations high on the interior face of wall, the previous recessed glulam beam seats are exposed.

Photo 7: Existing Beam Seats

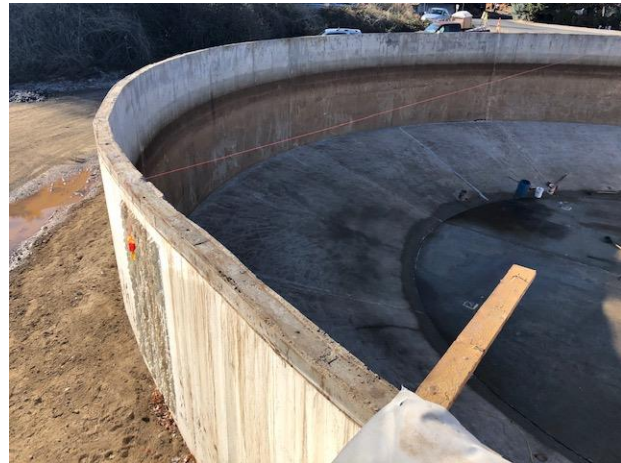
Photo 8: Existing Wall Exterior

The exterior paint is badly weathered including peeling, blistering, and staining (**Photo 8**) although this is considered a cosmetic rather than structural issue.

Paint blistering and other staining at the wall exterior is considered a cosmetic issue rather than a structural issue and the City may choose to blast or otherwise abrade the stains and remove blistering paint. If stains are difficult to remove, darker gray or tan concrete stain could be applied to the exterior to mask discoloration. Because concrete is porous, painting typically does not last as long as on other common construction materials, and repainting every 10 to 20 years should be anticipated.

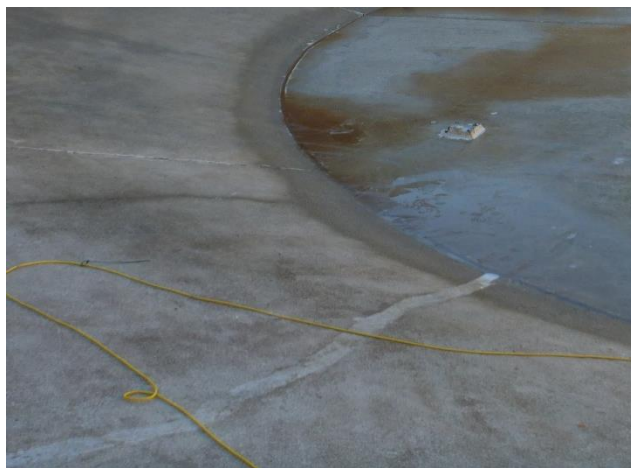
The existing joint material/sealant at joints in the floor were observed to be well-adhered to the concrete and did not appear to be degrading. Previously installed sealant over floor cracks (**Photo 9**) appeared to be in good condition and showed no sign of dampness or leaking. However, several un-sealed cracks (**Photo 10**) were observed in the floor slab. The cracks appeared mostly filled with silt and may not leak significantly, although no leak testing of the reservoir has been performed to verify the possibility.

Photo 9: Previously-Sealed Floor Crack

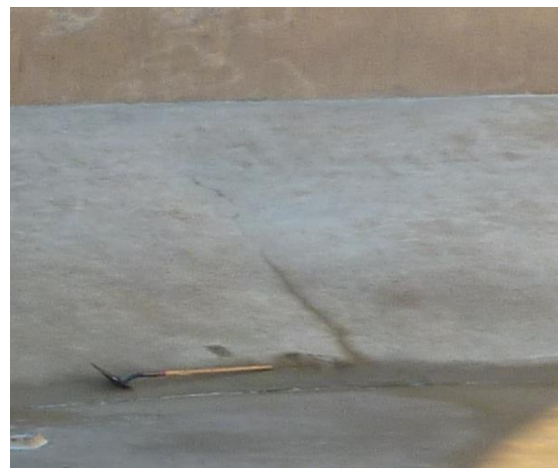
Photo 10: Actively Leaking Floor Crack

To prevent leakage, it is recommended that the cracks in the floor be sealed. Various methods are possible, listed as follows in order of effectiveness and difficulty. Any caulking or epoxy products must have National Sanitation Foundation (NSF) 61 certification.

1. Cover joint with membrane elastomer strip, epoxied at the edges. This provides a flexible repair that is not affected by minor concrete movement. Suggested product: Sika Combiflex SG system.
2. Route out the crack and fill with epoxy, crystalline grout, or caulk. Any of the products may work since the cracks do not appear to be moving, although epoxy can translate a moving crack through it. Suggested products: Xypex Patch-n-Plug, Euclid Tammsflex NS.
3. Clean the surface and apply a coat of epoxy, crystalline patch, or flexible patch, similar to what is seen on existing previously repaired cracks in the reservoir. This system is the most susceptible to damage from cracks that are still moving. Suggested product: Euclid Hey'Di SB/K-11 system.

Since the cracks do not appear to have a structural impact, but may still move slightly, especially when the reservoir is refilled, RH2 recommends either the first or second method.
