CASHMERE CITY COUNCIL MEETING  
MONDAY, JANUARY 11, 2021 6:00 P.M., CITY HALL

## SCADA MASTER PLAN

## **Draft Facility Condition Report**

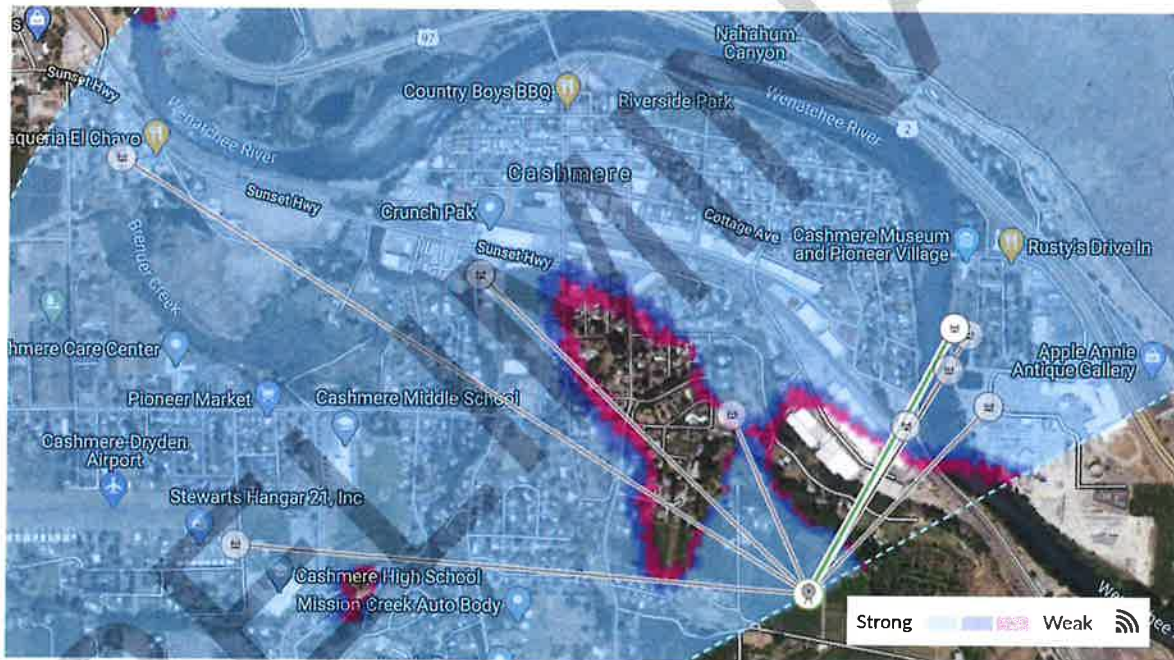
**Figure 1:**  
City High-Speed Network Potential Radio Communication Paths

Figure of 5 GHz Radio Communication Paths. Figure developed with Ubiquiti Airlink Software.

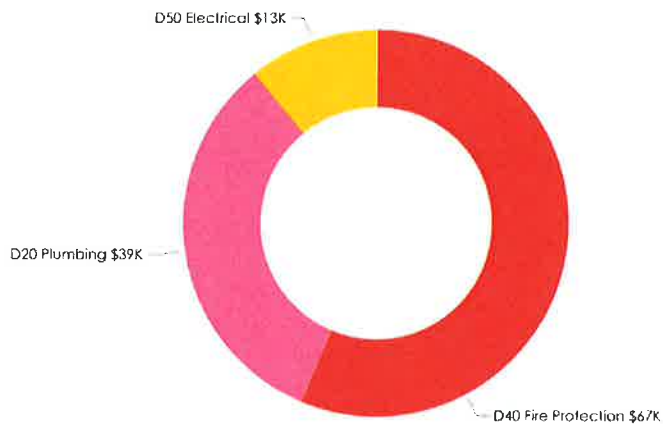
Figure 2. ODs totaled by System

The total OD amount for the Cashmere Public Library is estimated at \$119,000. Breakouts by system and action type are shown in **Figures 2 & 3** below.

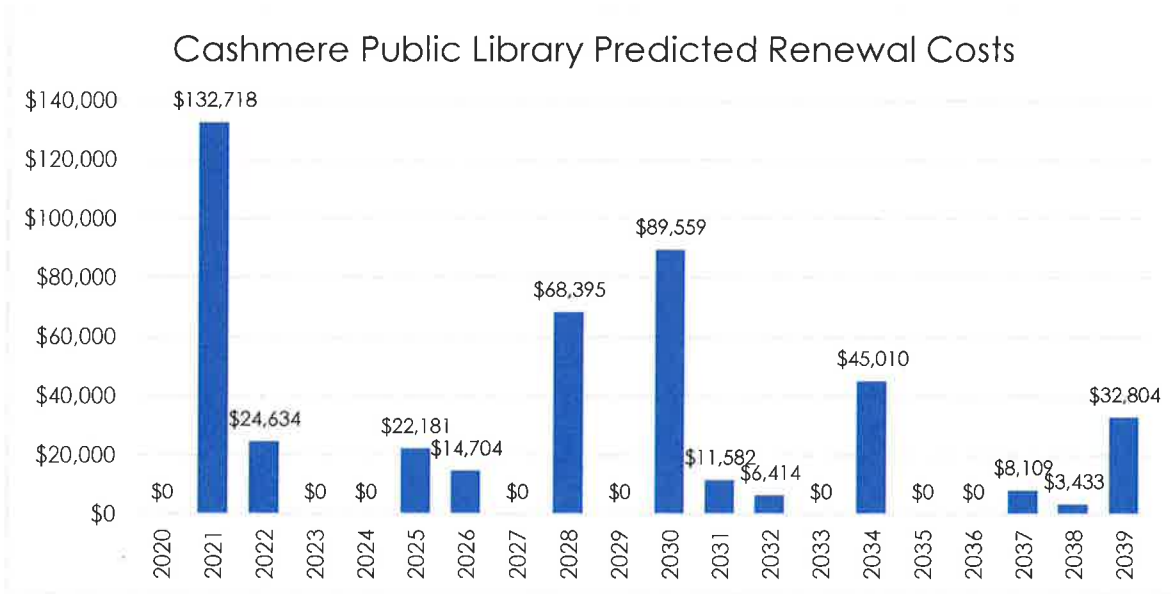
Figure 4. Total PRs by Year

**Figure 4** shows the modeled Predicted Renewal cost for the Cashmere Public Library from 2020 – 2039. For details about what systems are due for renewal each year, please review the Microsoft BI dashboard that accompanies this report.

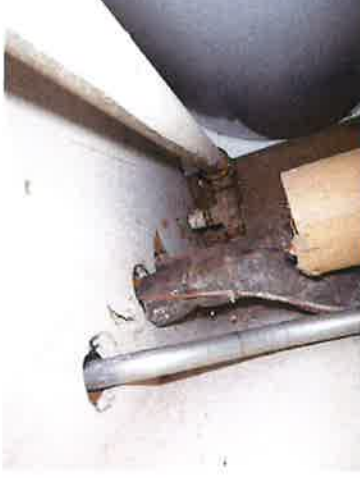
**Deficient Material: Galvanized pipe**

Replace with copper and/or PEX.

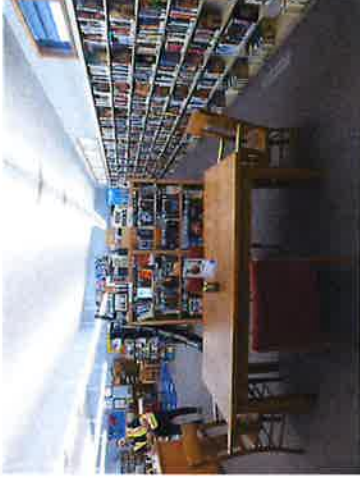
**Deficient Material: Fire Sprinkler**

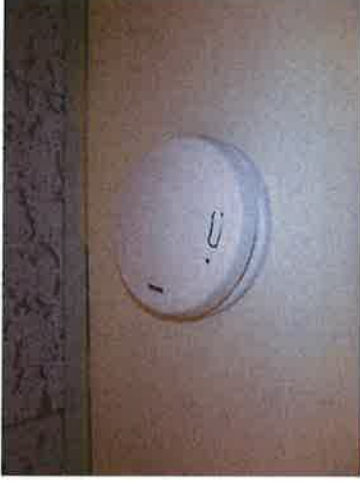
**Deficient Material: Fire alarm**
